The People's Perception on the Vitogo River Flooding

By Alisi W Daurewa

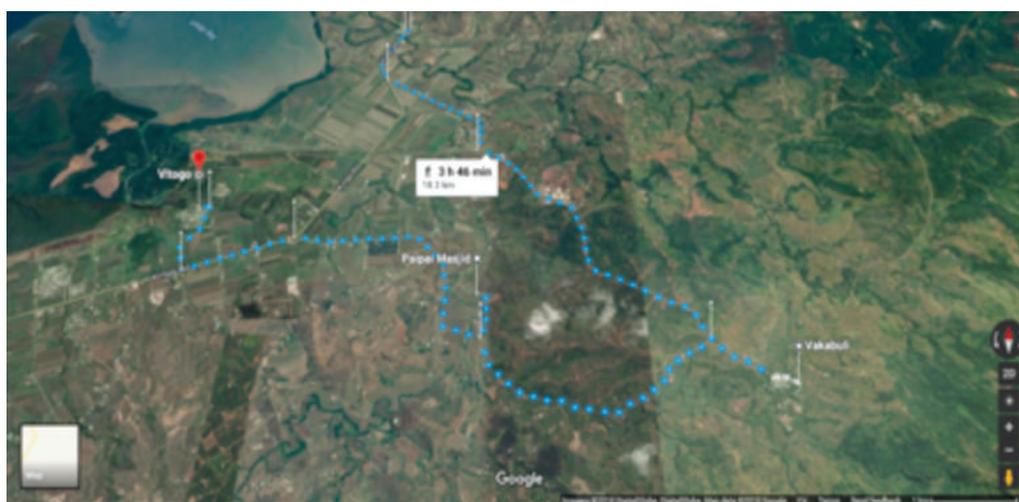
Figure 1 above reveals an aerial view of the affected parts of Vitogo District:

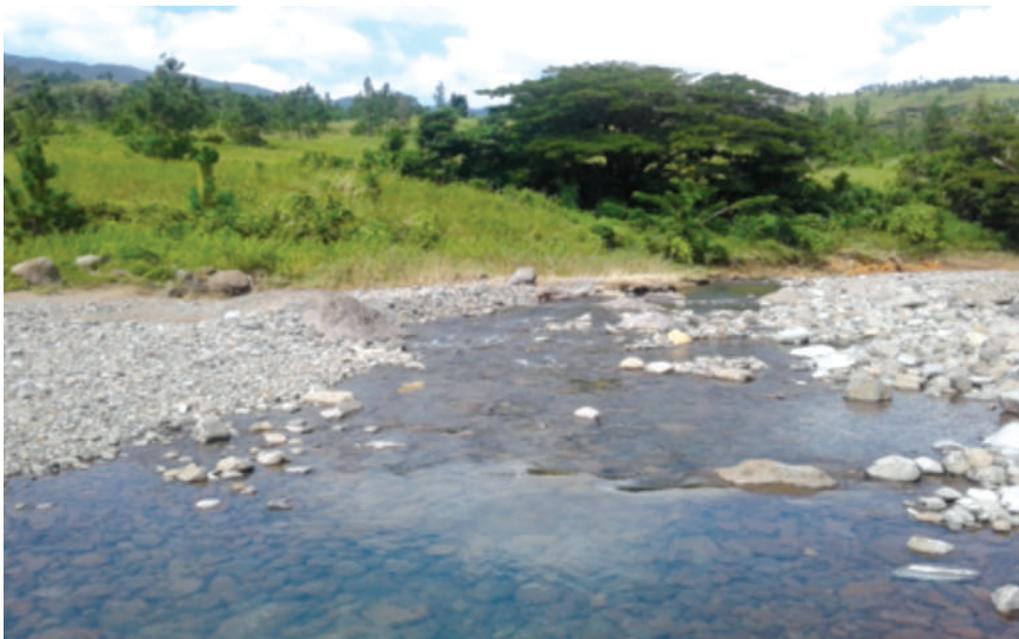
Figure 2 above shows a narrowed Vakabuli River, filled with gravel and stones from Natubaibua hill.

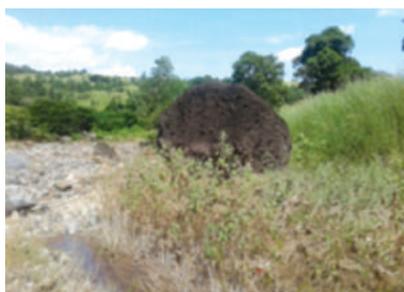
Figure 3: Boulder on river bank

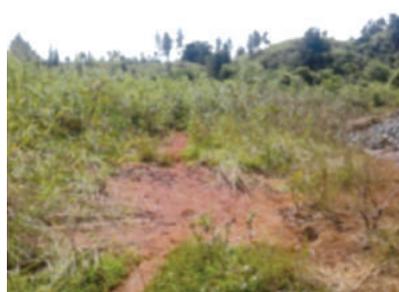
Figure 4: Waterlogged land

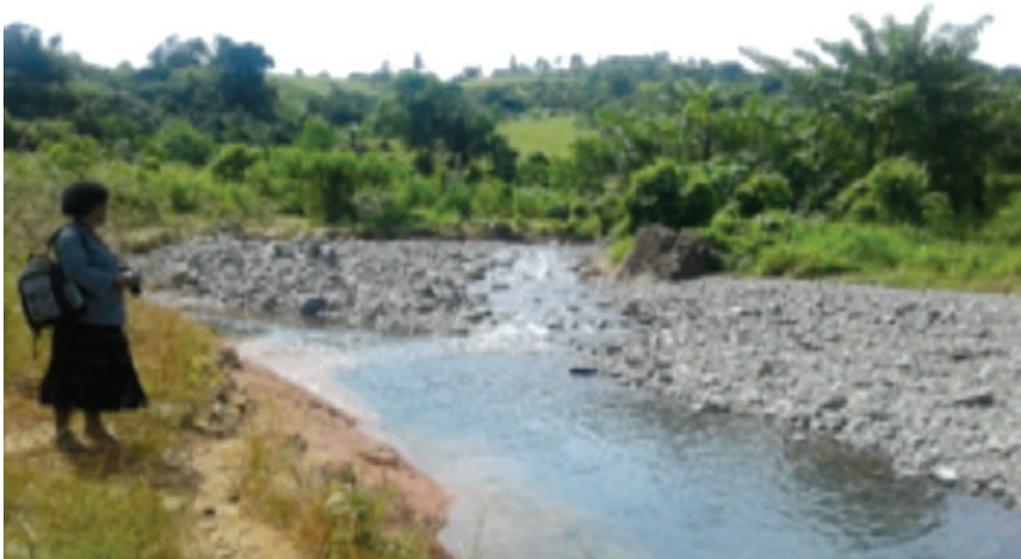
Figure 5: Narrowed river with gravel in Vakabuli

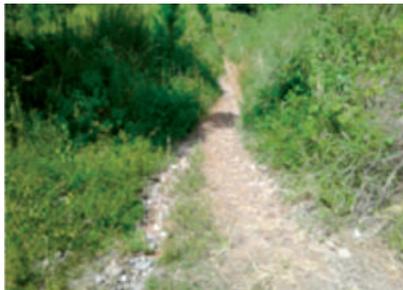
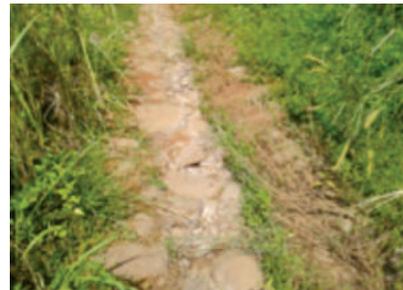
- Accessibility to farms is limited by a now narrowed farm road that was built years ago with the help of the villagers – Figure 6 below:
